LABORATORY OF CABLE TESTING AND ENVIROMENTAL TESTS

TEST REPORT No. 4770-ZLK/2017

Degree of protection provided by enclosures. IP65 tests of lamp enclosure SP-102.

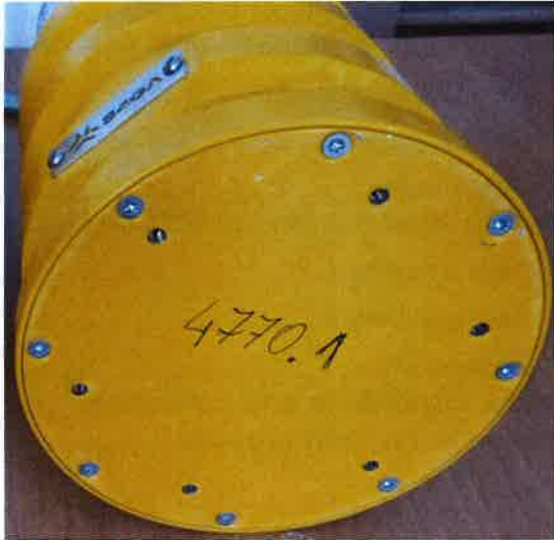
4770.1/2017
2	Lamp enclosure SP-102	<p>No serial number</p>

No.	Name according to the supplier	Serial number	Laboratory code
1	Lamp enclosure SP-102	<p>No serial number</p>

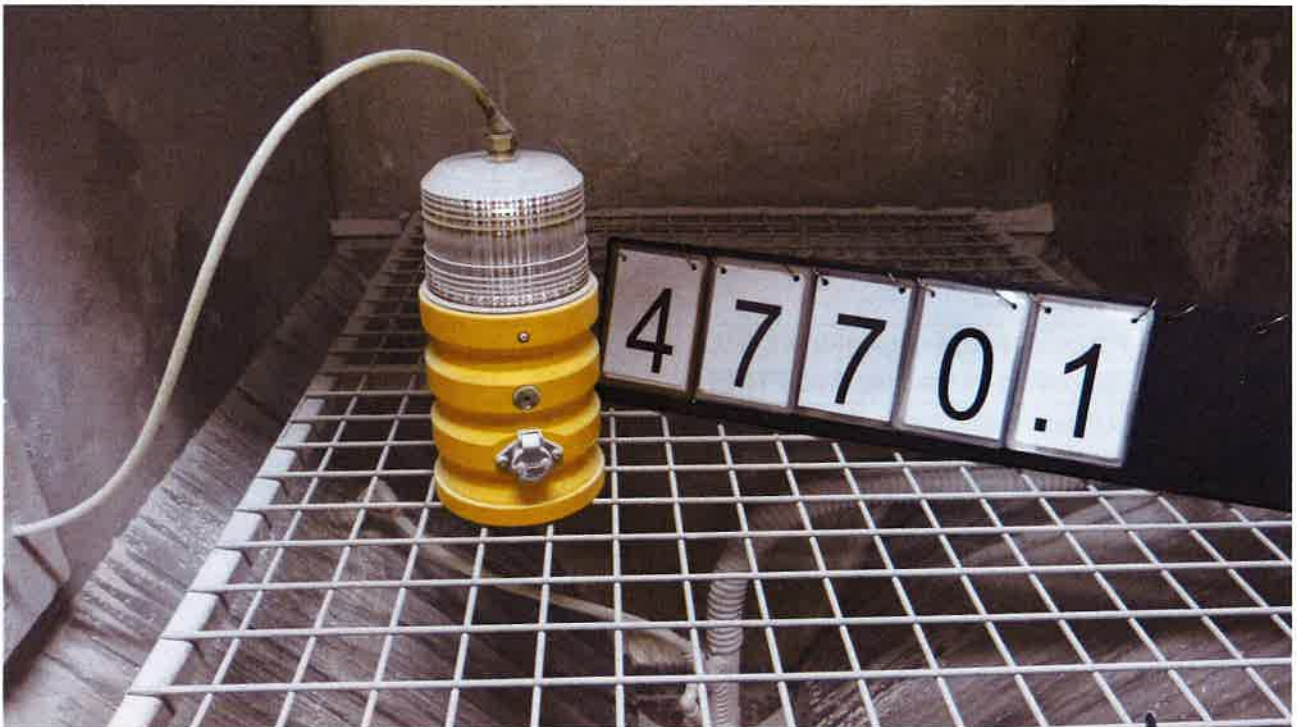
Fig. 1. Test sample 4770.1 in the dust chamber – after the test IP6X

Test was performed in accordance with the recommendations of PN-EN 60529:2003, clause 13.4: test IP6X – protection against dust (category 1 enclosure).

- Type of dust: Talcum powder,
- Talcum powder's grain size: <75 um,
- The amount of dust: 2 kg,
- The dust chamber size: 1 m³,
- Test duration: 8 h.

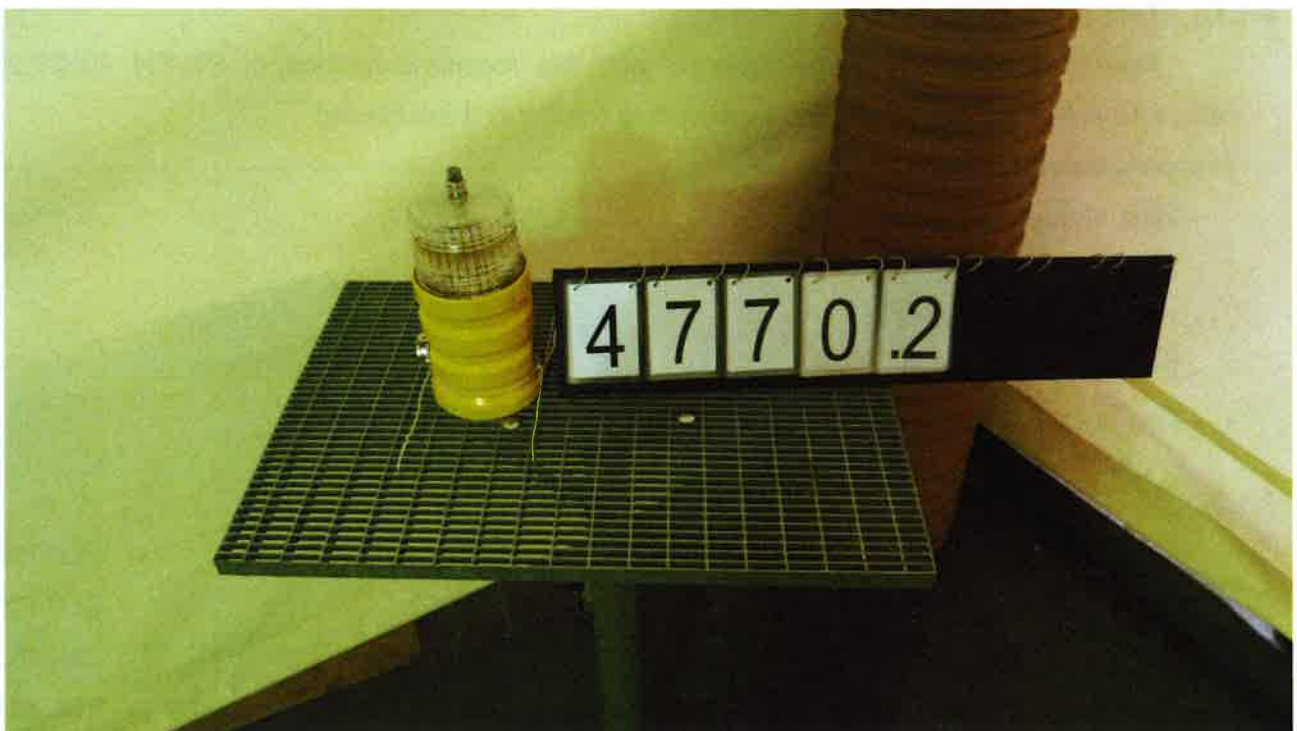
Fig. 2. Test sample 4770.2 at the test stand - after the test IPX5

Test was performed in accordance with standard PN-EN 60529:2003, clause 14.2.5: protection against water jet.

- temperature of water jet: $(24,8 \pm 2,0)$ °C,
- water flow: $(12,5 \pm 1,0)$ l/min,
- test duration: 3 min.

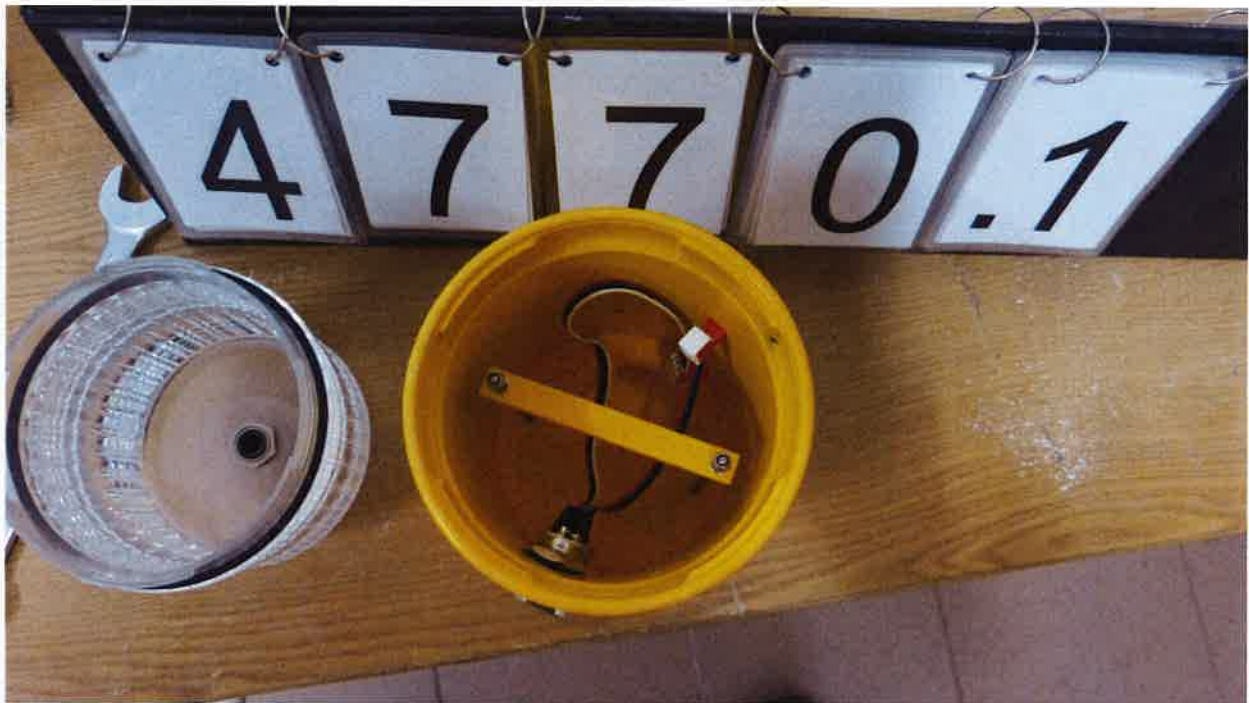
After the test, the EUT was opened and inspected according to the point 2 of test report. Dust did not penetrate into tested object (Fig. 3). Test result positive.

Fig. 3. Visual internal inspection after the test of IP6X. EUT – 4770.1/2017

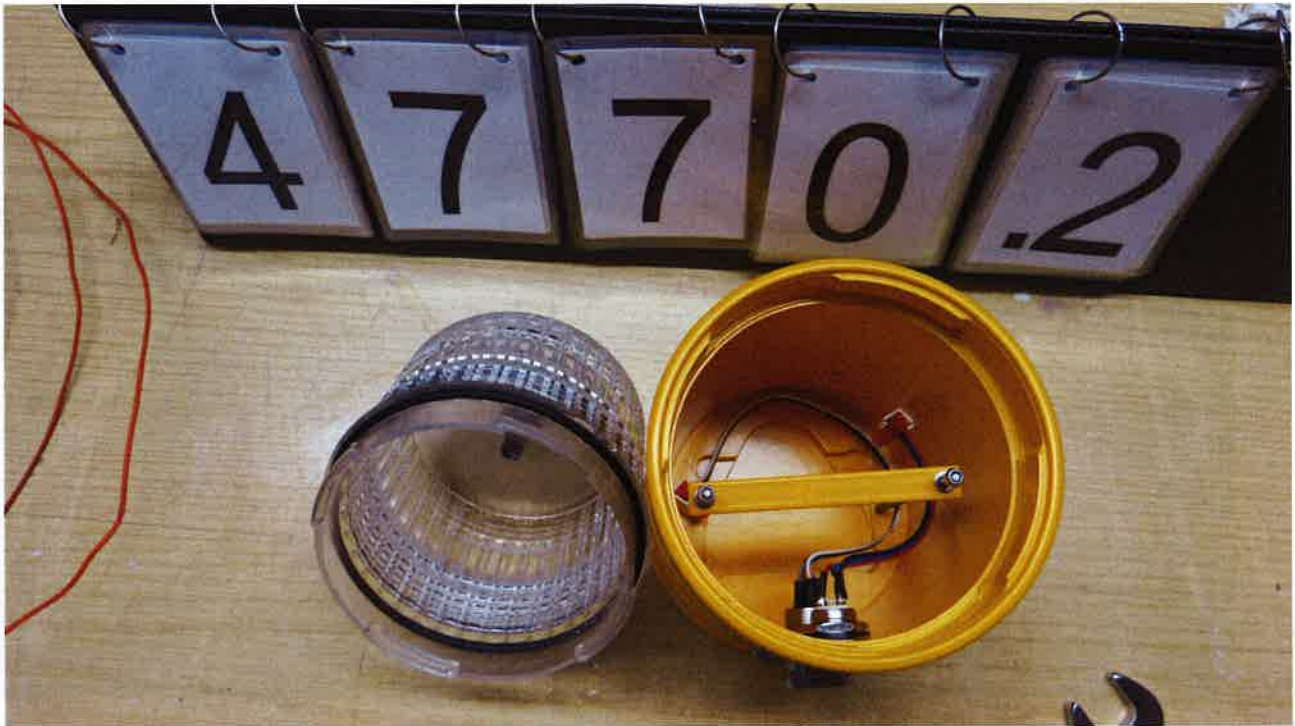
After the test, the EUT was opened and inspected according to the point 2 of test report (Fig. 4). Water did not penetrate into tested object. Test result positive.

Fig. 4. Visual internal inspection after the test of IPX5. EUT – 4770.2/2017
