REPORT

from test No. LL/039/2021

Subject: Technical research of frangible connections v4

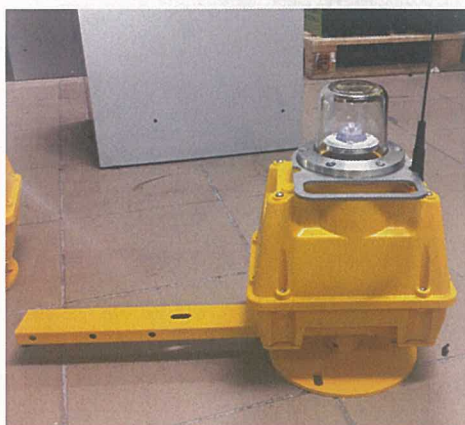
Photo 2. airport lamp with frangible connection v4

The client provided 6 frangible connection samples with complete airport lamps for research. Sample numbers given by the laboratory: LL/039/21/01 + .../06.

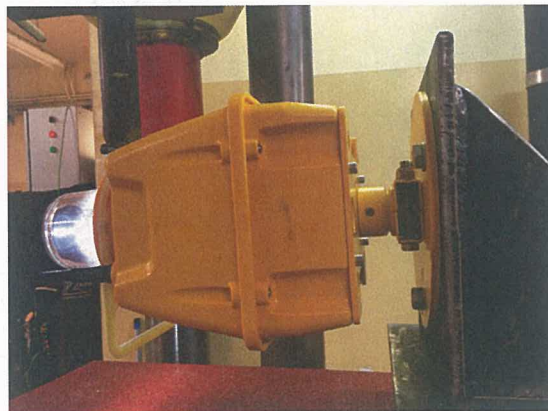
Photo 3. lamp install method 1

In order to perform the test, the connections with lamps were individually mounted on the test stand and bent by force perpendicular to the connection until it was broken. The result of the test is the force registered when the connection breaks.

The connection was tested with complete airport lamp. The distance between the point of application of the bending force and the weakest point of the connection was 245 mm.

Sample No.	lamp install method	The force used to break the connection [N]	The moment used to break the connection [Nm]	Requirements according to FAA AC 150-5345-46E and Doc 9157 AN901 ICAO ADM Part 6 Frangibility
LL/039/20/01	1	2517	617	the connection breaking moment should be in the range of 203 Nm – 678 Nm
LL/039/20/02		2417	592	
LL/039/20/03		2661	651	
Average		2532	620	
LL/039/20/04	2	2030	497	
LL/039/20/05		2111	517	
		2335	572	
Average		2159	529

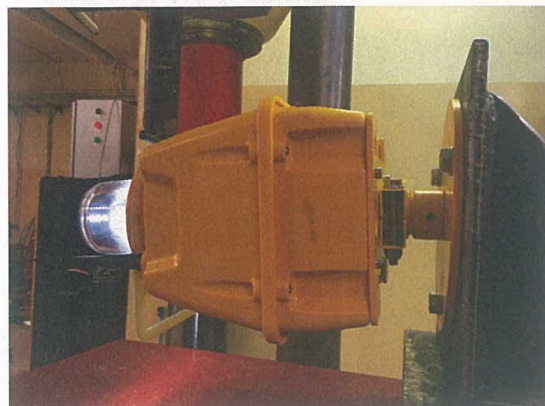
Photo 4. lamp install method 2

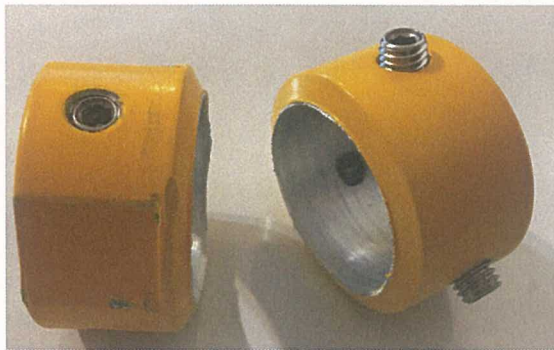
Photo 5. Connection after tests

Based on the tests, the moment required to break the connection (for both install method) is within the range specified in FAA AC 150-5345-46E and Doc 9157 AN901 ICAO ADM Part 6 Frangibility.
