## TEST REPORT

Number: BOS/2441/BE/22

Subject: Thermal testing of Precision Approach Path Indicator (PAPI)

### Precision Approach Path Indicator (PAPI)

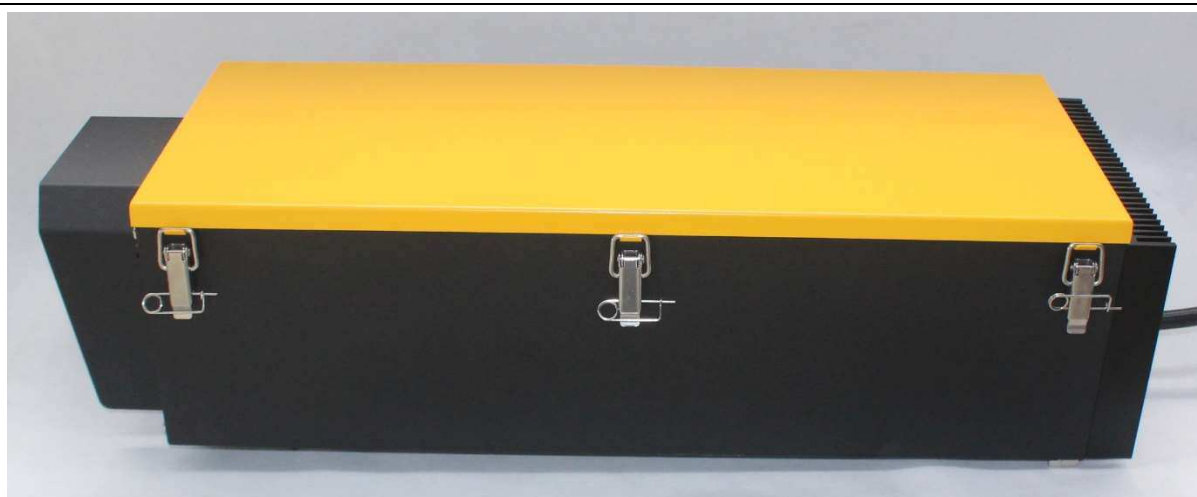
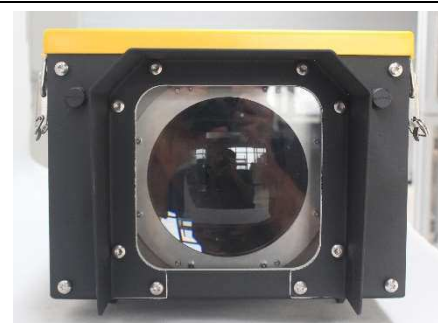
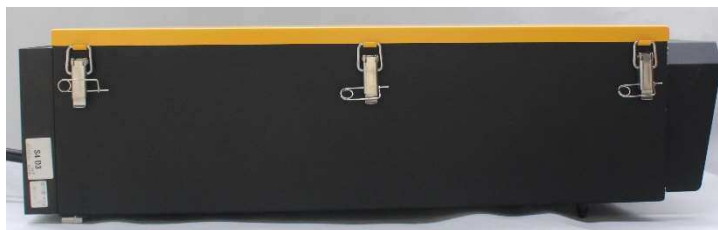
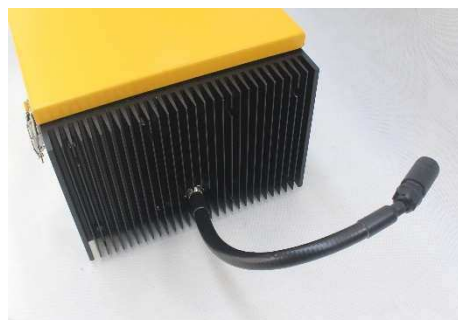
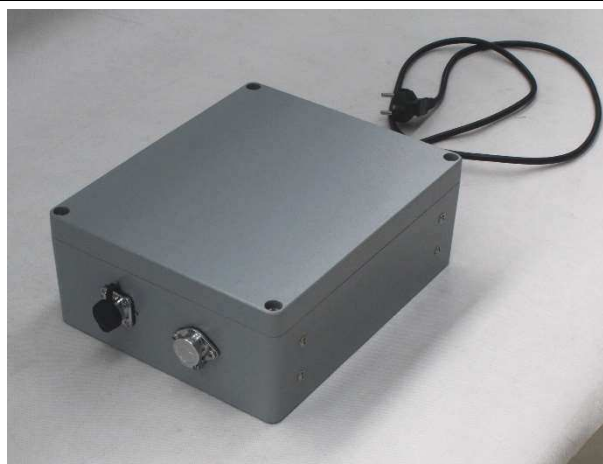
Fig. 1 Tested object

Supplier: Solutions4GA Sp. z o.o.  
 Model: LED PAPI S4GA  
 Marking(by Customer): LED PAPI S4GA 1 x 80W, L880, Style B, Class I  
 Dimension: 908mm×325mm×235mm (l×w×h)  
 Quantity: 1 pc  
 Sampling method: delivered by Customer on 19.04.2022

a) overall view

b) front view

c) side view

d) back view

e) power supply

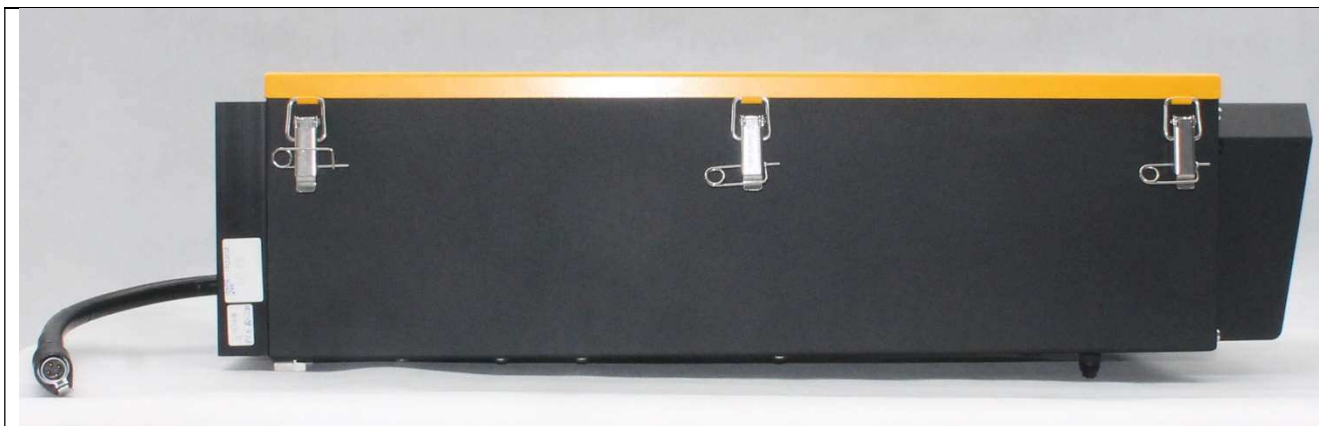
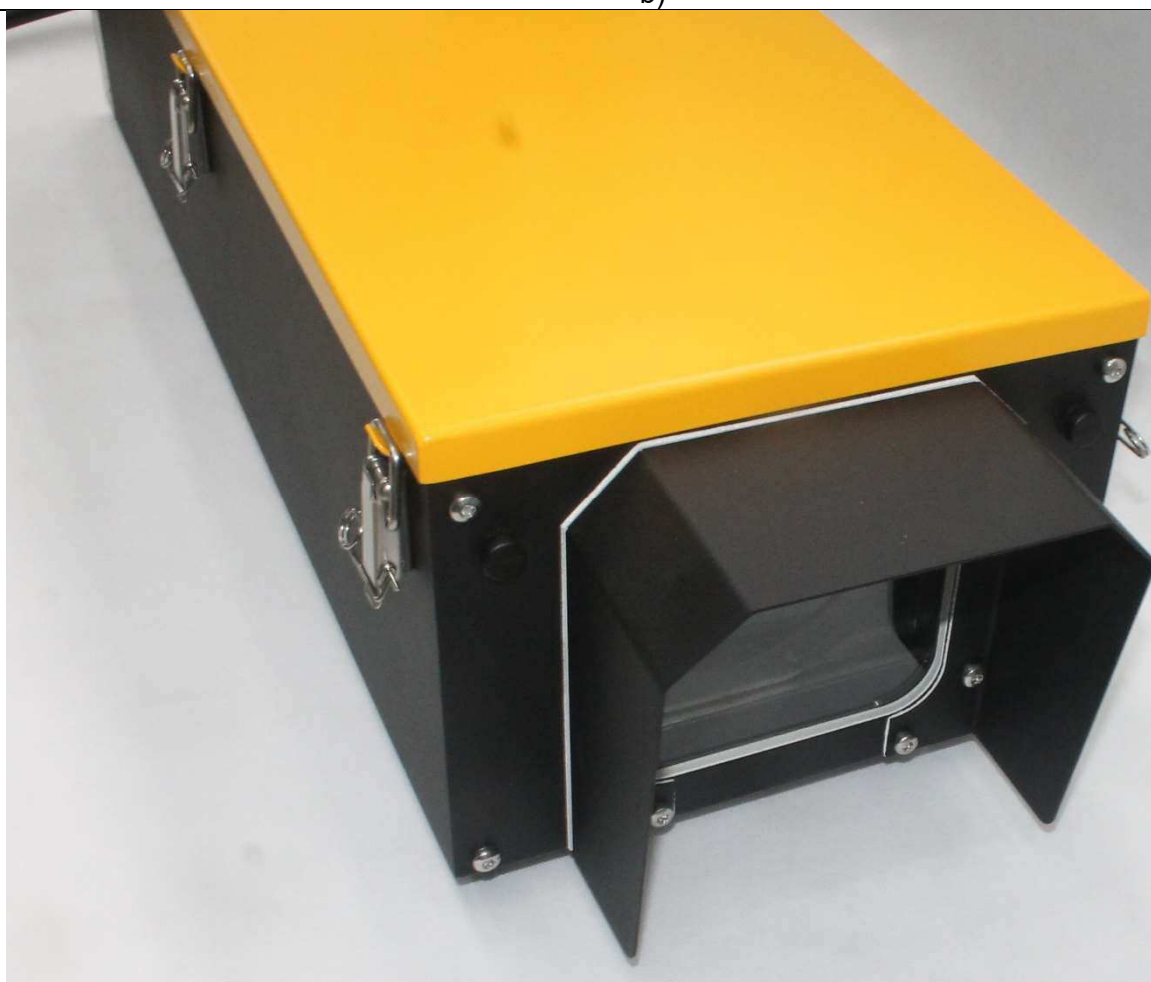
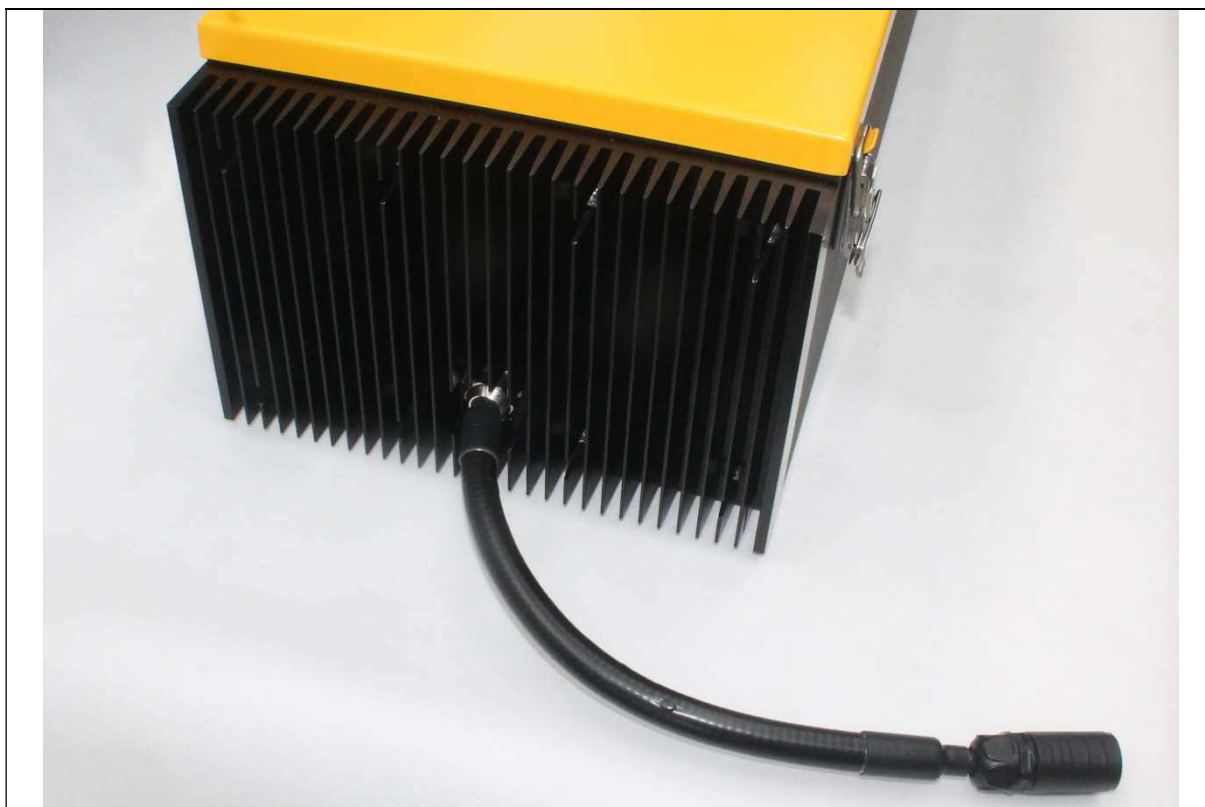
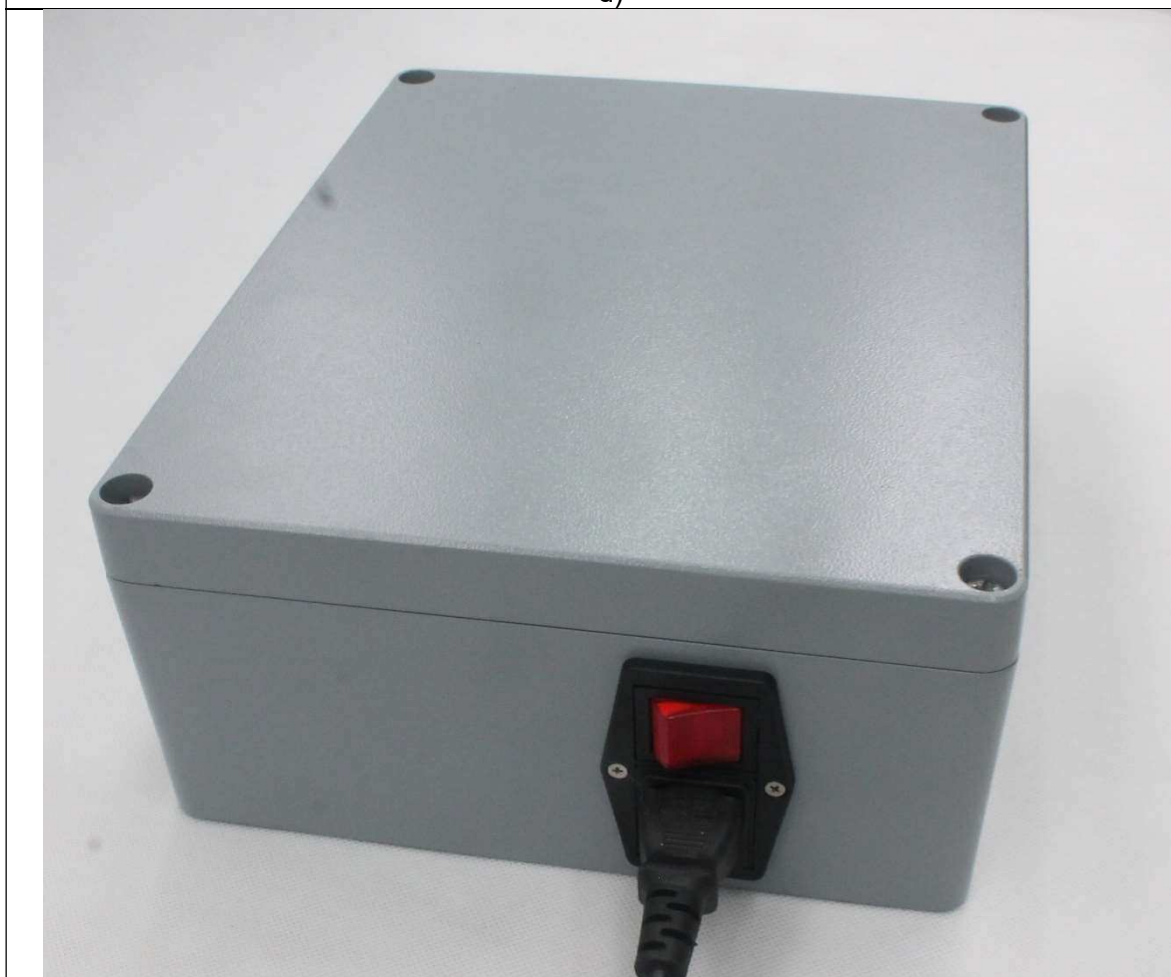
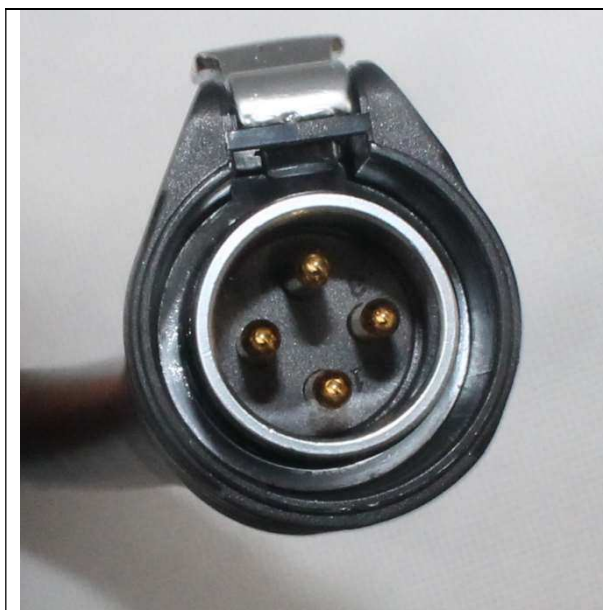
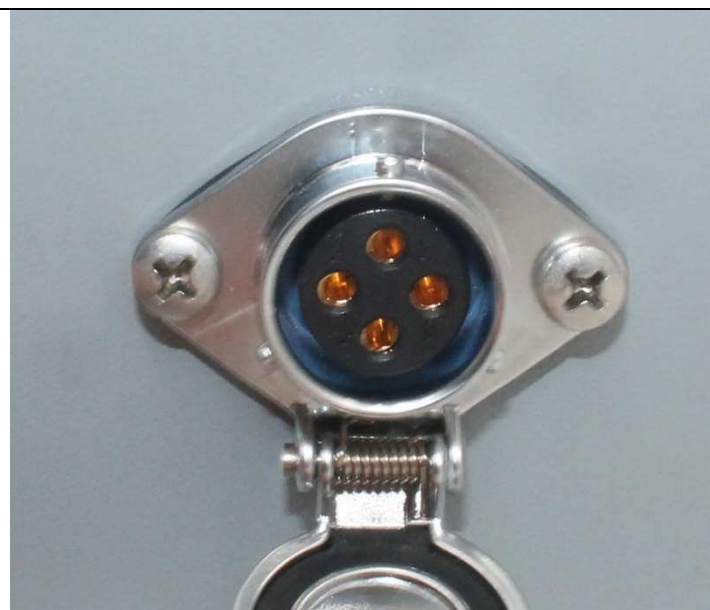
Fig. 4 Tested object after the test

No visual changes after the test were observed. The functionality of tested object has been preserved. Tested object after the test – Fig. 4.
