AERODYNAMIC RESEARCH LABORATORY

Examination of the wind resistance of the SP-401 lamp with solar panel mounting

Report No: ...41/CNTA/19/P

Research made for: Solutions4GA Sp. z o.o. (S4GA)

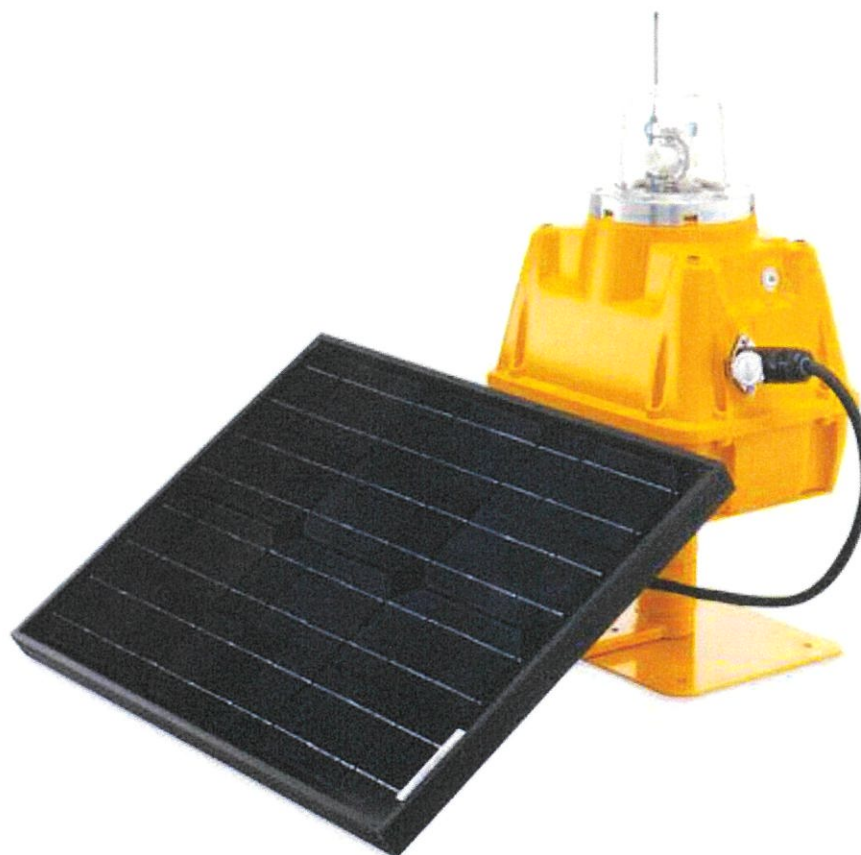
The height	442 mm
The width	450 mm
The lenght	528 mm
The mass	12,4 kg

Figure 1 The SP-401 lamp with solar panel mounting

The **SP-401 lamp with solar panel mounting** manufactured and delivered by **Solutions4GA Sp. z o.o. (S4GA)** was the test object in this aerodynamic research..

The lamp was mounted on the permanent basis provided by the test orderer in the configuration on the test stand in the T-3 wind tunnel.

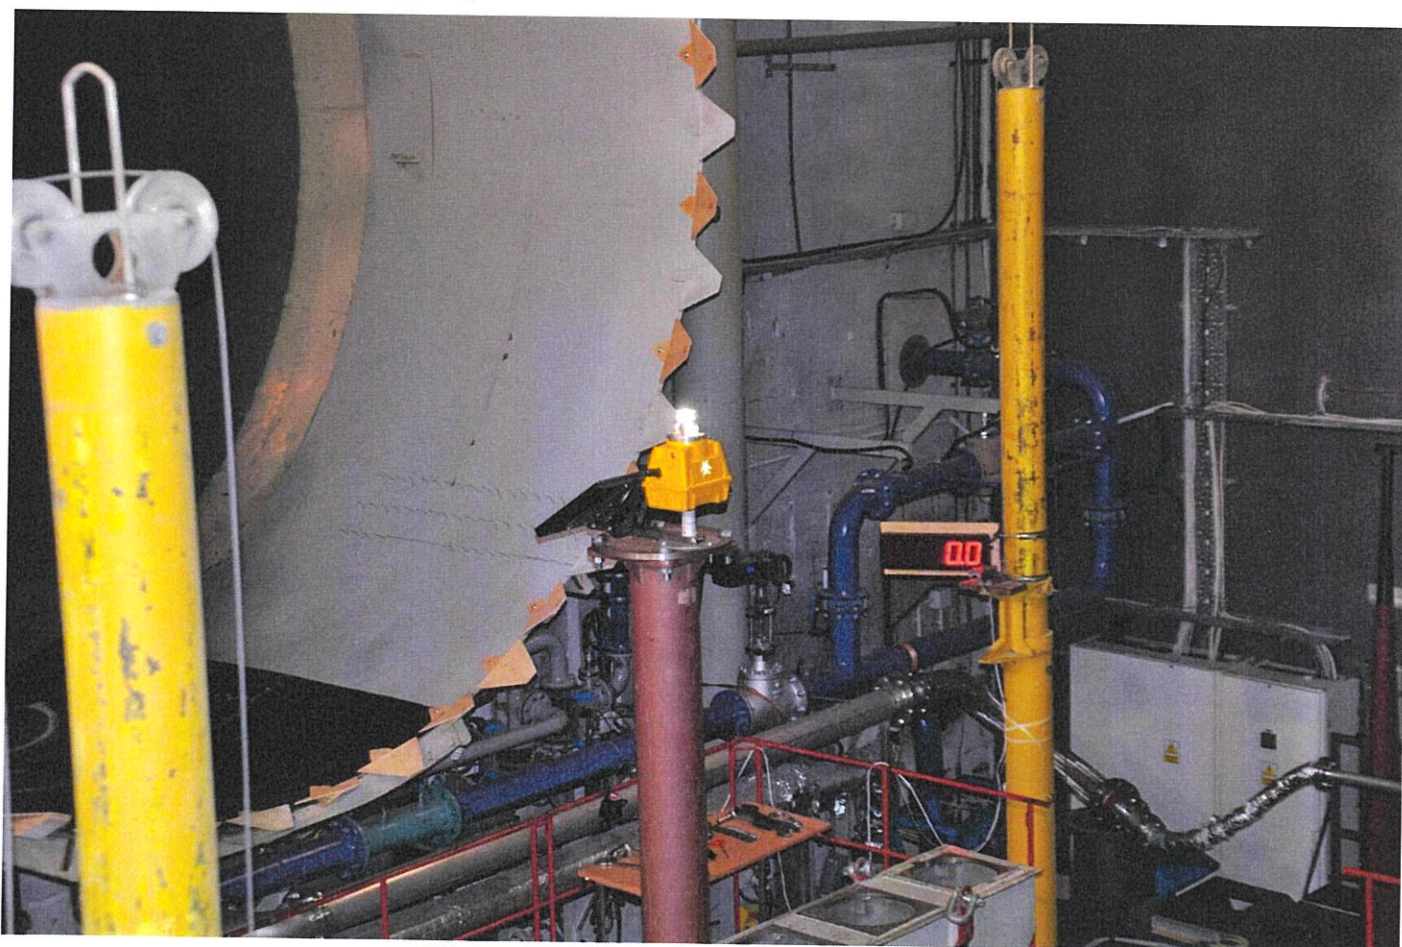
The device, together with the base provided by the manufacturer, was installed at the test stand of the T-3 wind tunnel.

Figure 3 The SP-401 lamp with solar panel mounting on the test stand in the T-3 wind tunnel

The device was in the on-turn (the lamp emitted the light in a continuous mode), the test was carried out at the airflow velocity of 67m/s (the mechanical resistance and the correctness of the work of the device was assessed).

Once the set speed has been reached, the test object was rotated around the vertical axis (β) in the range of 0° - 360° (with the angular speed of $18^\circ/\text{min}$) without stop. (the angle value was displayed on the display and recorded on the surveillance system camera). Additionally, during the whole test at $360^\circ/0^\circ$, 270° , 180° , 90° angular positions 5-minute-long tests were carried out.

The test was carried out within one wind tunnel cycle (run **604.19** and run **606.19**). The tunnel monitoring system allowed the inspection of the mechanical condition of the test object and stand without the need to stop the airflow in the facility (by observing from the monitoring system). The correct operation of the device was also validated (during the test, the lamp was turned on).

The test confirmed that the device **is not damaged** when an air flow velocity reaches 240 km/h (67 m/s) regardless of the direction of the inflow.
